## Appendix D Cultural Heritage Risk Assessment

## Beerburrum to Nambour Rail Upgrade Project

Cultural Heritage Risk Assessment

Prepared for SMEC Australia and Building Queensland | 20 November 2019

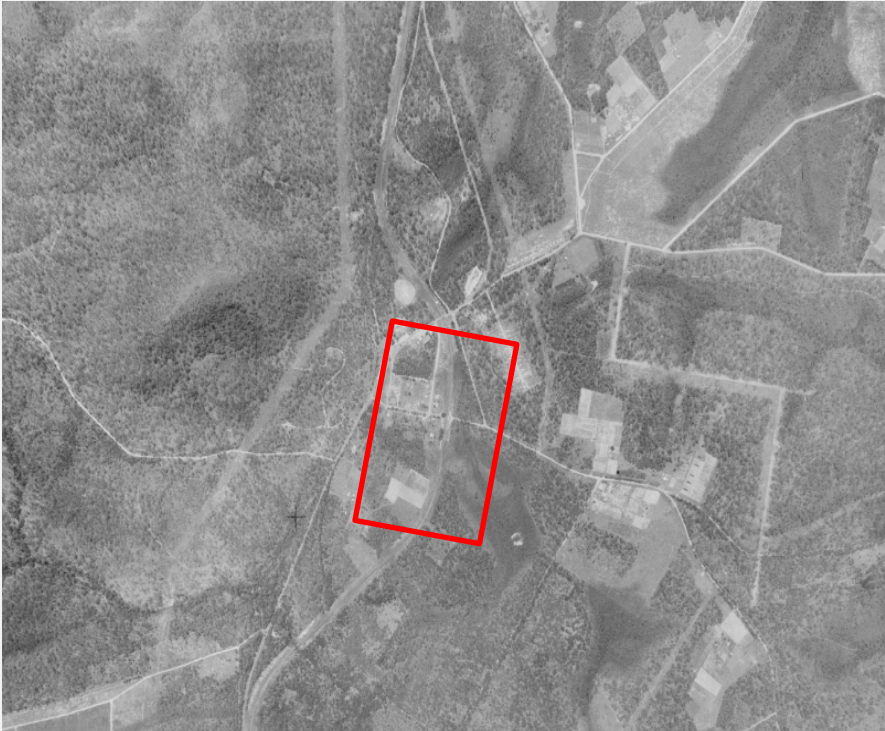
</div> <p><b>Plate 1: Aerial image of the Beerburrum Railway station in 1953. The Project area is denoted by the red box.</b></p> <p>The earliest aerial photograph of the Beerburrum Railway Station shows isolated clearing. The railway line is evident in the aerials.</p>	<ul style="list-style-type: none"><li>• A mixture of land uses are evident from this aerial, including developed areas and undisturbed areas.</li><li>• No surface disturbance or significance ground disturbance has occurred directly north of Beerburrum railway station</li></ul>

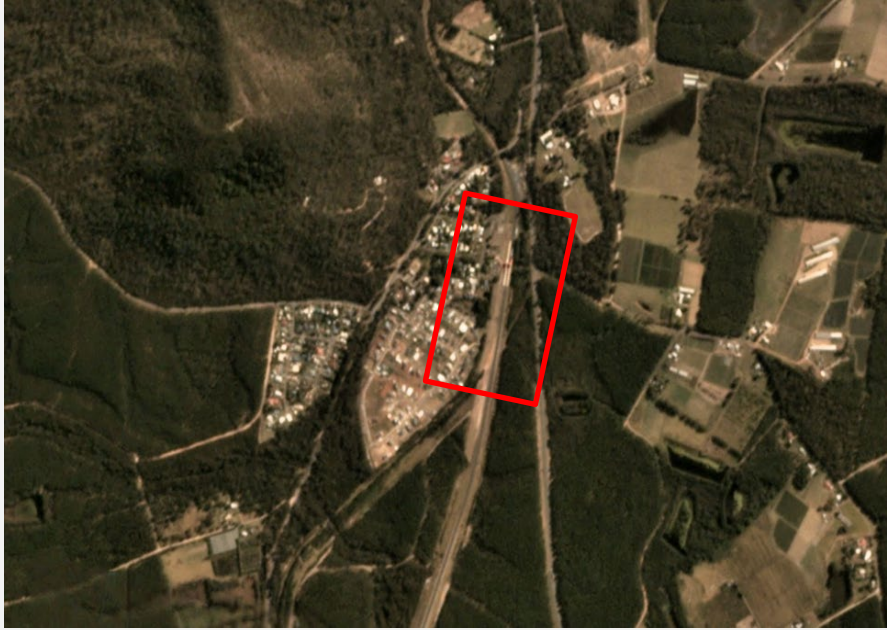
<p data-bbox="256 969 1147 1032"><b>Plate 2. Aerial image of the Project area in 2017. Beerburrum Railway Station is denoted by the red box.</b></p> <p data-bbox="256 1048 1147 1285">The aerial photograph of the Beerburrum Railway Station shows the development of Beerburrum and surrounding pastoral properties. The railway line has been expanded and is highly evident in the aerial. Remnant vegetation is present north and east of the railway station. Remnant vegetation is evident near the former Station Master's residence and surrounding area of the former station complex.</p>	<ul data-bbox="1217 315 1441 869" style="list-style-type: none"> <li>• Almost all the vegetation has now been removed from the block.</li> <li>• Surface Disturbance and Significant Ground Disturbance has occurred along the railway line, Beerburrum Settlement and surrounding pastoral areas.</li> </ul>

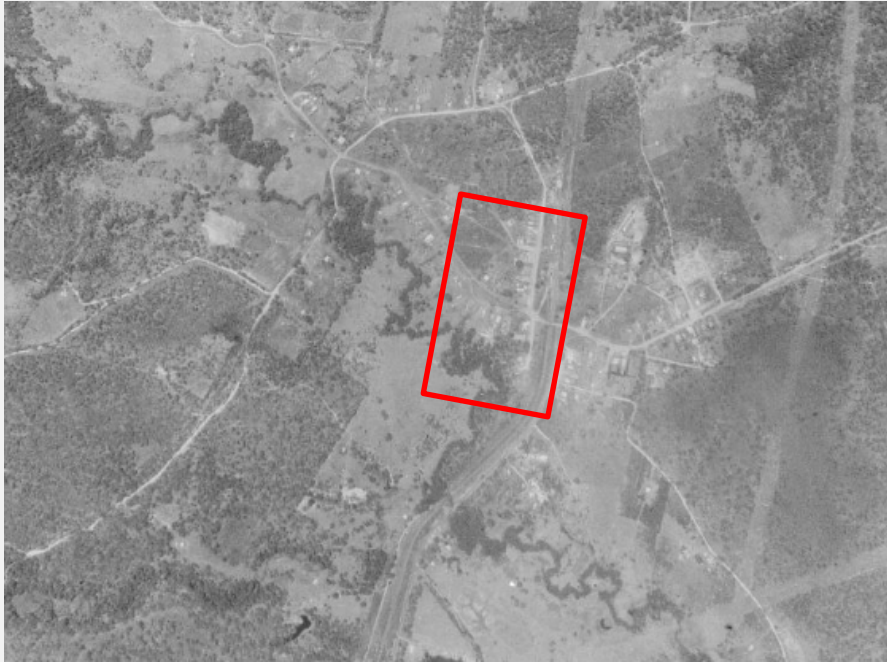
</div> <p><b>Plate 3: Aerial image of the Landsborough Railway station in 1953. The Project area is denoted by the red box.</b></p> <p>The earliest aerial photograph of Landsborough shows clearing for the established settlement, surrounding pastoral plots and the railway line. The railway line is evident in the aerials. Remnant vegetation is present along Mellum Creek.</p>	<ul style="list-style-type: none"><li>• A mixture of land uses are evident from this aerial, including developed areas and undisturbed areas.</li><li>• No surface disturbance or significance ground disturbance has occurred west of the railway line.</li></ul>

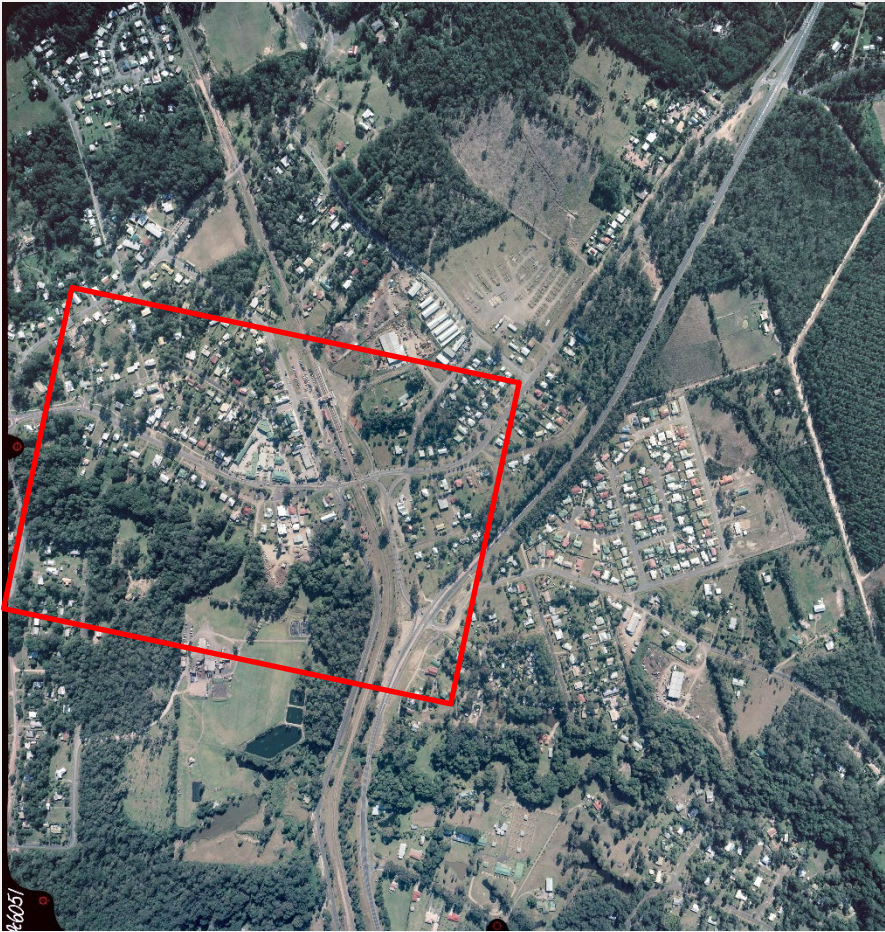
<p data-bbox="256 1256 1161 1321"><b>Plate 4. Aerial image of the Landsborough area in 2003. Beerburrum Railway Station is denoted by the red box.</b></p> <p data-bbox="256 1335 1161 1489">The aerial photograph of Landsborough shows its development of and surrounding pastoral properties. The railway line has been expanded and is highly evident in the aerial. Remnant vegetation is present west of the railway along Mellum Creek.</p>	<ul style="list-style-type: none"> <li>• Almost all the vegetation has now been removed from the block.</li> <li>• Surface Disturbance and Significant Ground Disturbance has occurred along the railway line, Landsborough Settlement and surrounding pastoral areas.</li> <li>• Remnant vegetation is present along Mellum Creek.</li> </ul>
